AIRCRAFT INCIDENT REPORT

BOEING 747, N732PA

RENTON AIRPORT

DECEMBER 13, 1969

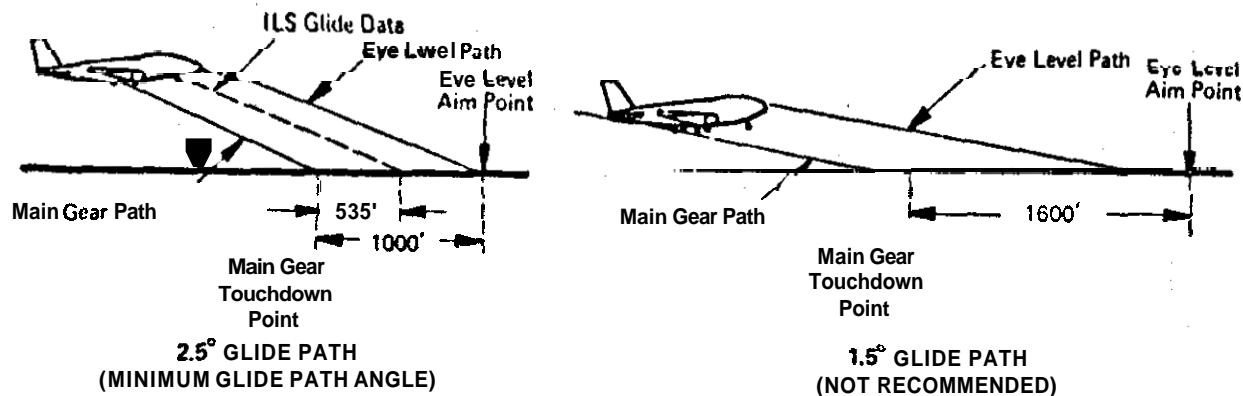
APPROACH AND LANDING GEOMETRY

The Safety Board believes that the pilot did not select an aiming point sufficiently distant (**in** keeping with his glide slope) to assure a landing on the runway. Also, no modification of the glide slope was performed which was sufficient and timely, in order to overcome the deficiency in the glide slope. **In** all other aspects the approach was flown with good procedures and control.

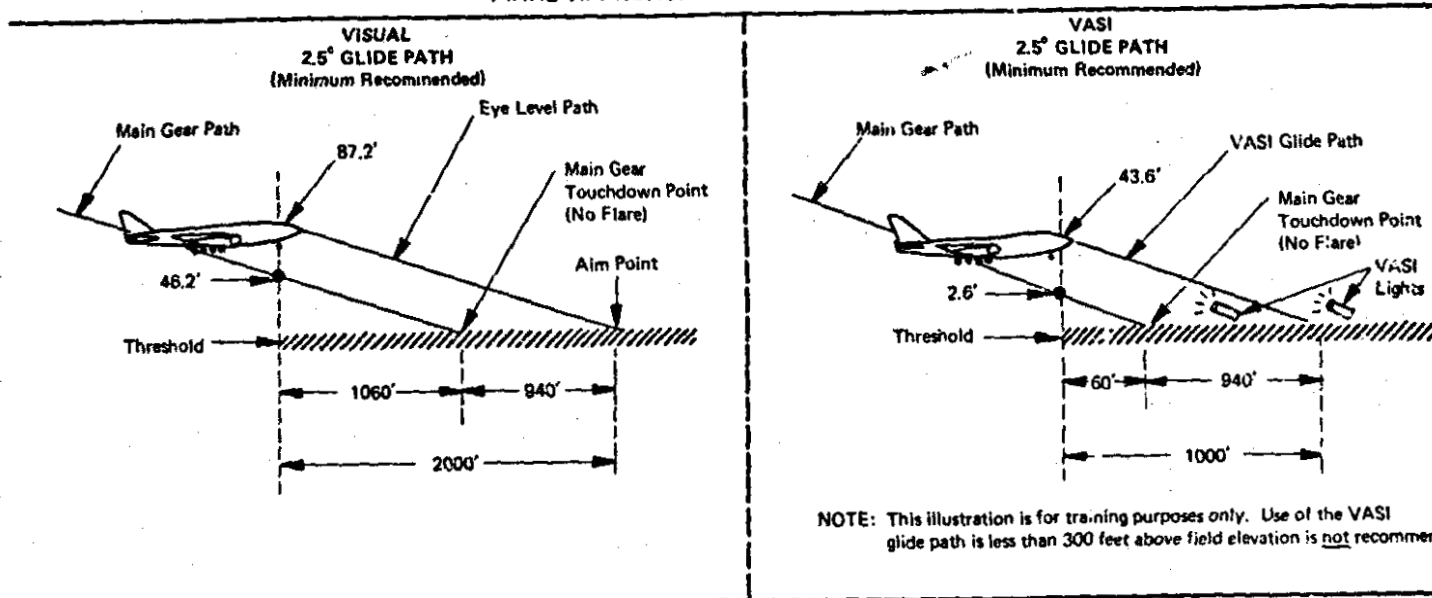
FINAL APPROACH AND LANDING GEOMETRY

The Board determines that the probable cause of this incident was the premature touchdown of the aircraft during a visual approach to a relatively short runway, induced by the pilot's not establishing a glidepath which would assure runway threshold passage with an adequate safety margin, under somewhat unusual environmental and psychological conditions.

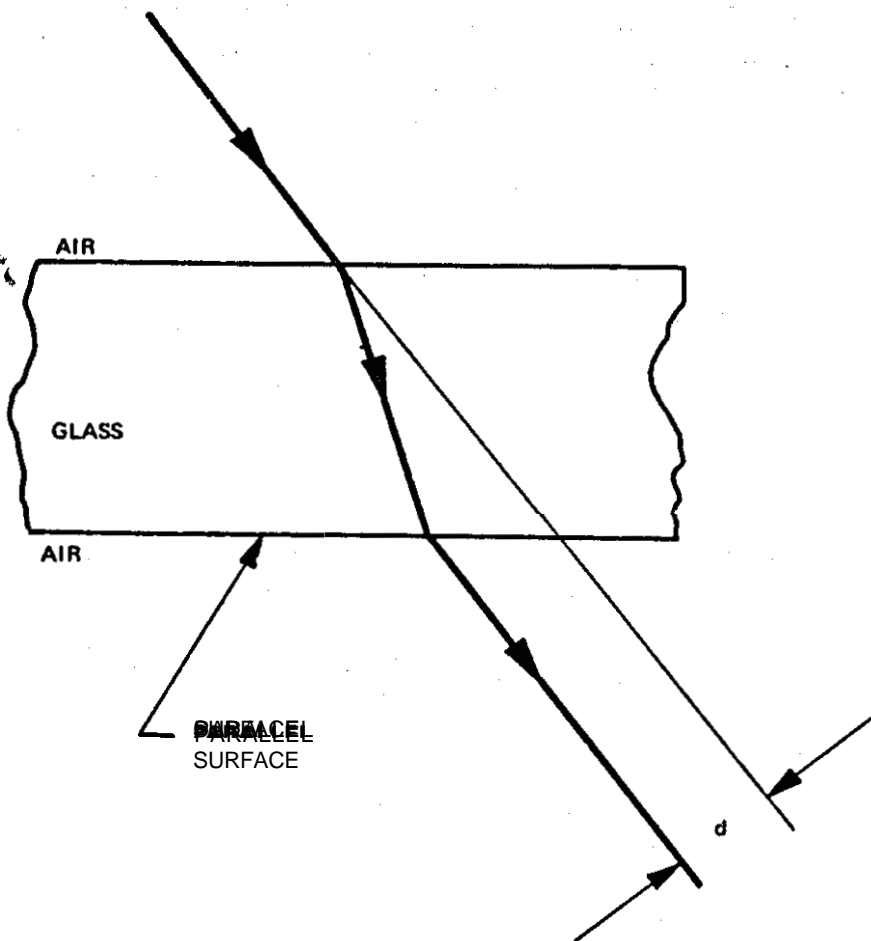
ATTACHMENT 4.

The Board considered the possibility that the curved windshield may have produced distortion or deviation sufficient to have caused the pilot to think that he was higher than he was. A Boeing study reveals that the total displacement is 9.6 feet in 1,000 feet, an amount which would be hardly discernible.

WHEN THE LIGHT BEAM LEAVES A SURFACE PARALLEL TO THE FIRST, IT IS PARALLEL TO THE ENTERING BEAM. THE BEAM IS DISPLACED A DISTANCE "d" FROM ITS ORIGINAL PATH. DISPLACEMENT IS RELATIVELY SMALL.

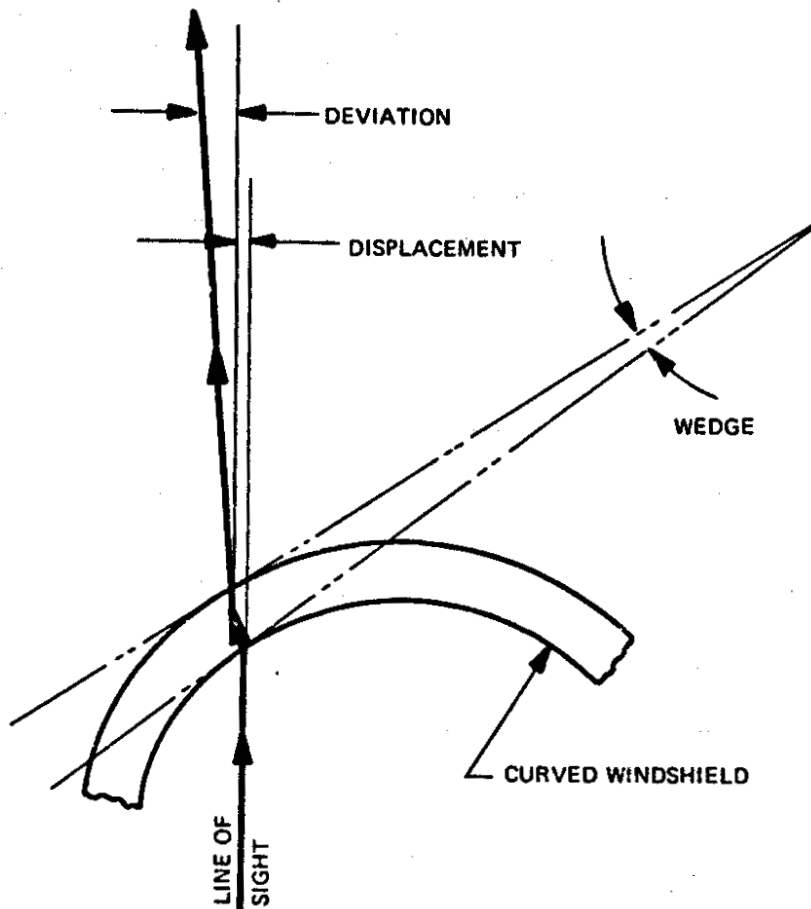
ATTACHMENT 5

WHEN THE SURFACE THE LIGHT ENTERS IS NOT PARALLEL TO THE SURFACE FROM WHICH IT LEAVES, THE DIRECTION OF THE LIGHT IS CHANGED. THIS IS CALLED THE "WEDGE EFFECT."
